Technical Report SL-98-1
March 1998

Performance of Lightly Reinforced Concrete Intake Towers Under Selected Loadings

Final report

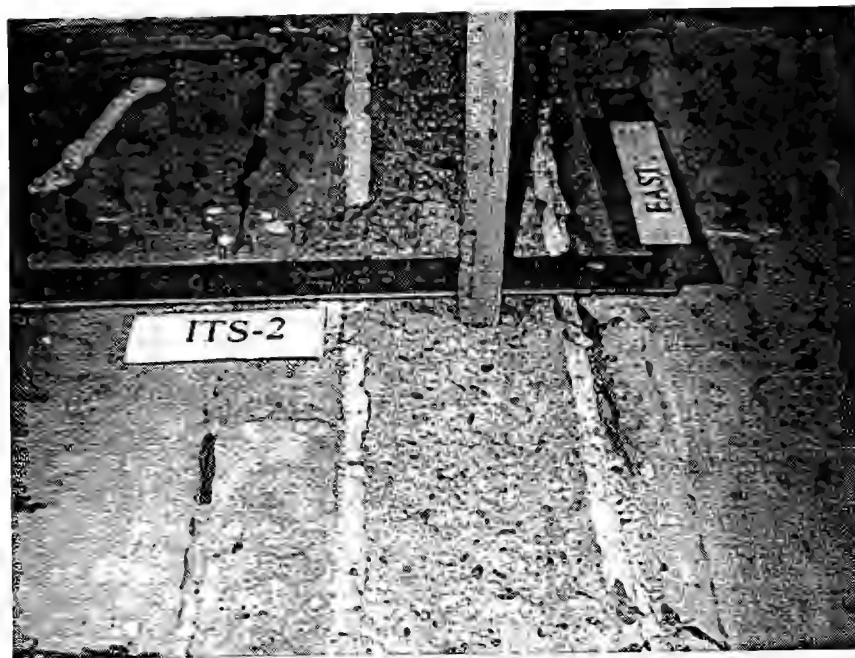
Figure 76. Close-up view of failure plane under east wall of ITS-2.

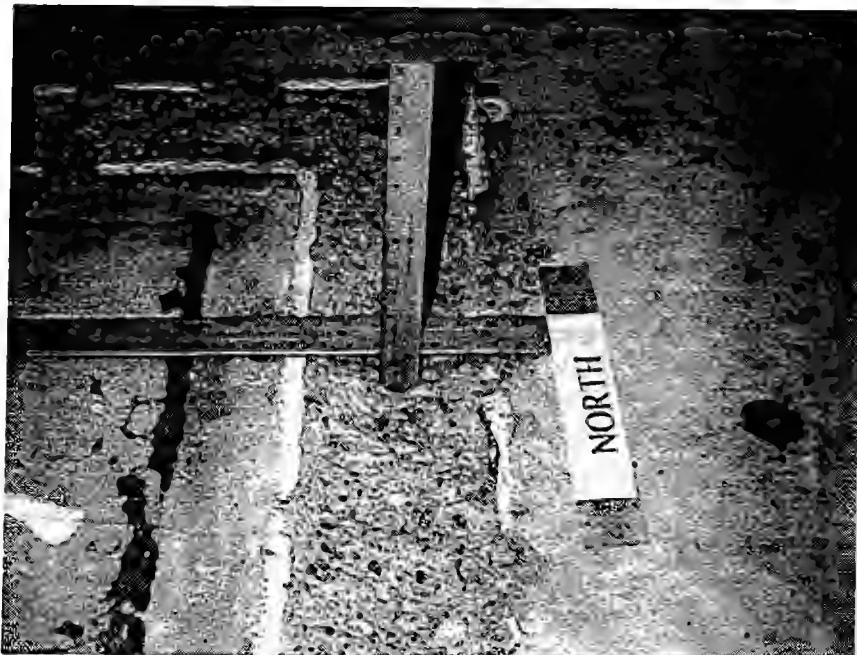
Figure 77. Close-up view of failure plane under north wall of ITS-2.

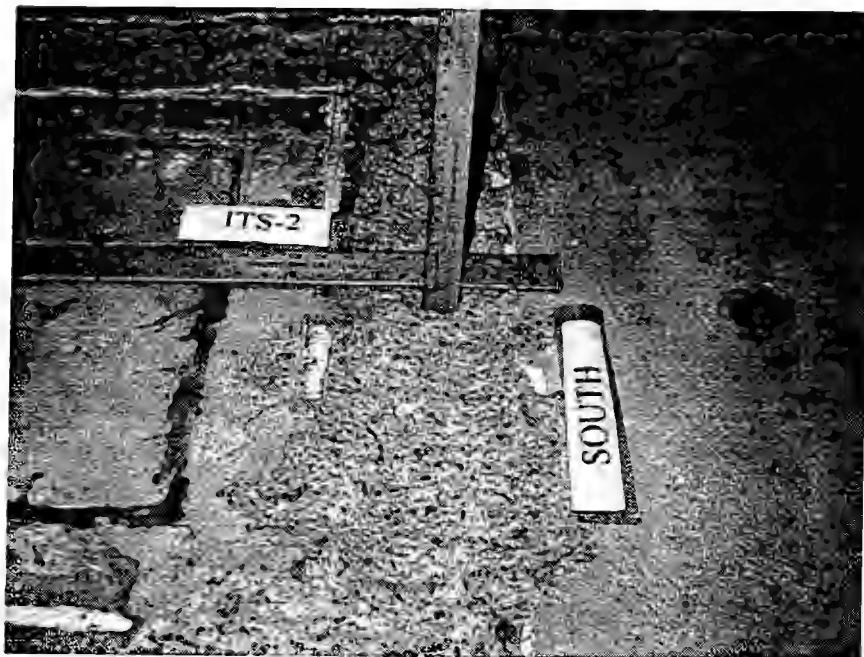
Figure 78. Close-up view of failure plane under south wall of ITS-2.

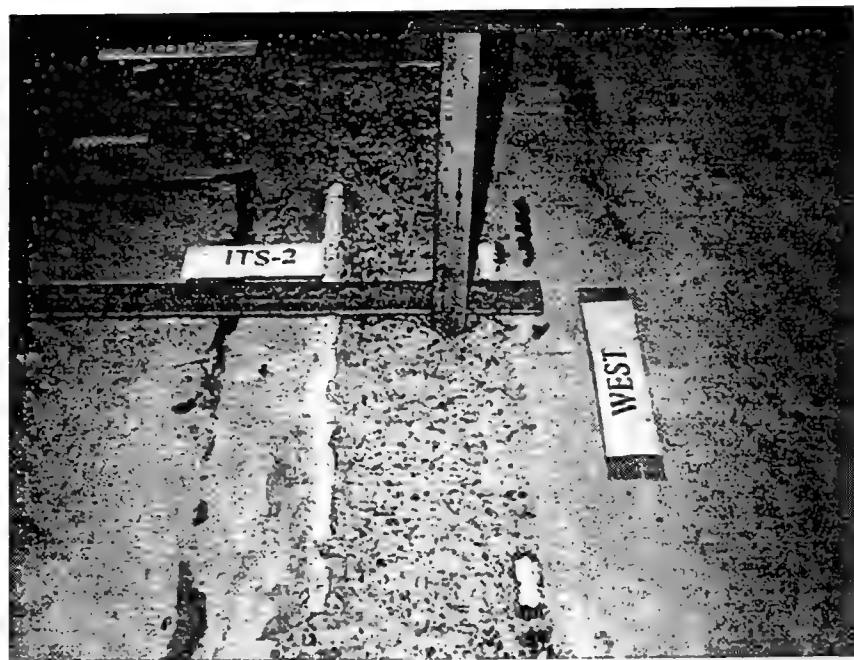
Figure 79. Close-up view of failure plane under west wall of ITS-2.
